# Expanded Site Inspection

**CHEMETCO  
ILD 048 843 809  
*HARTFORD, ILLIOIS***

October 3, 2008

**Title:** CERCLA Expanded Site Inspection for Chemetco

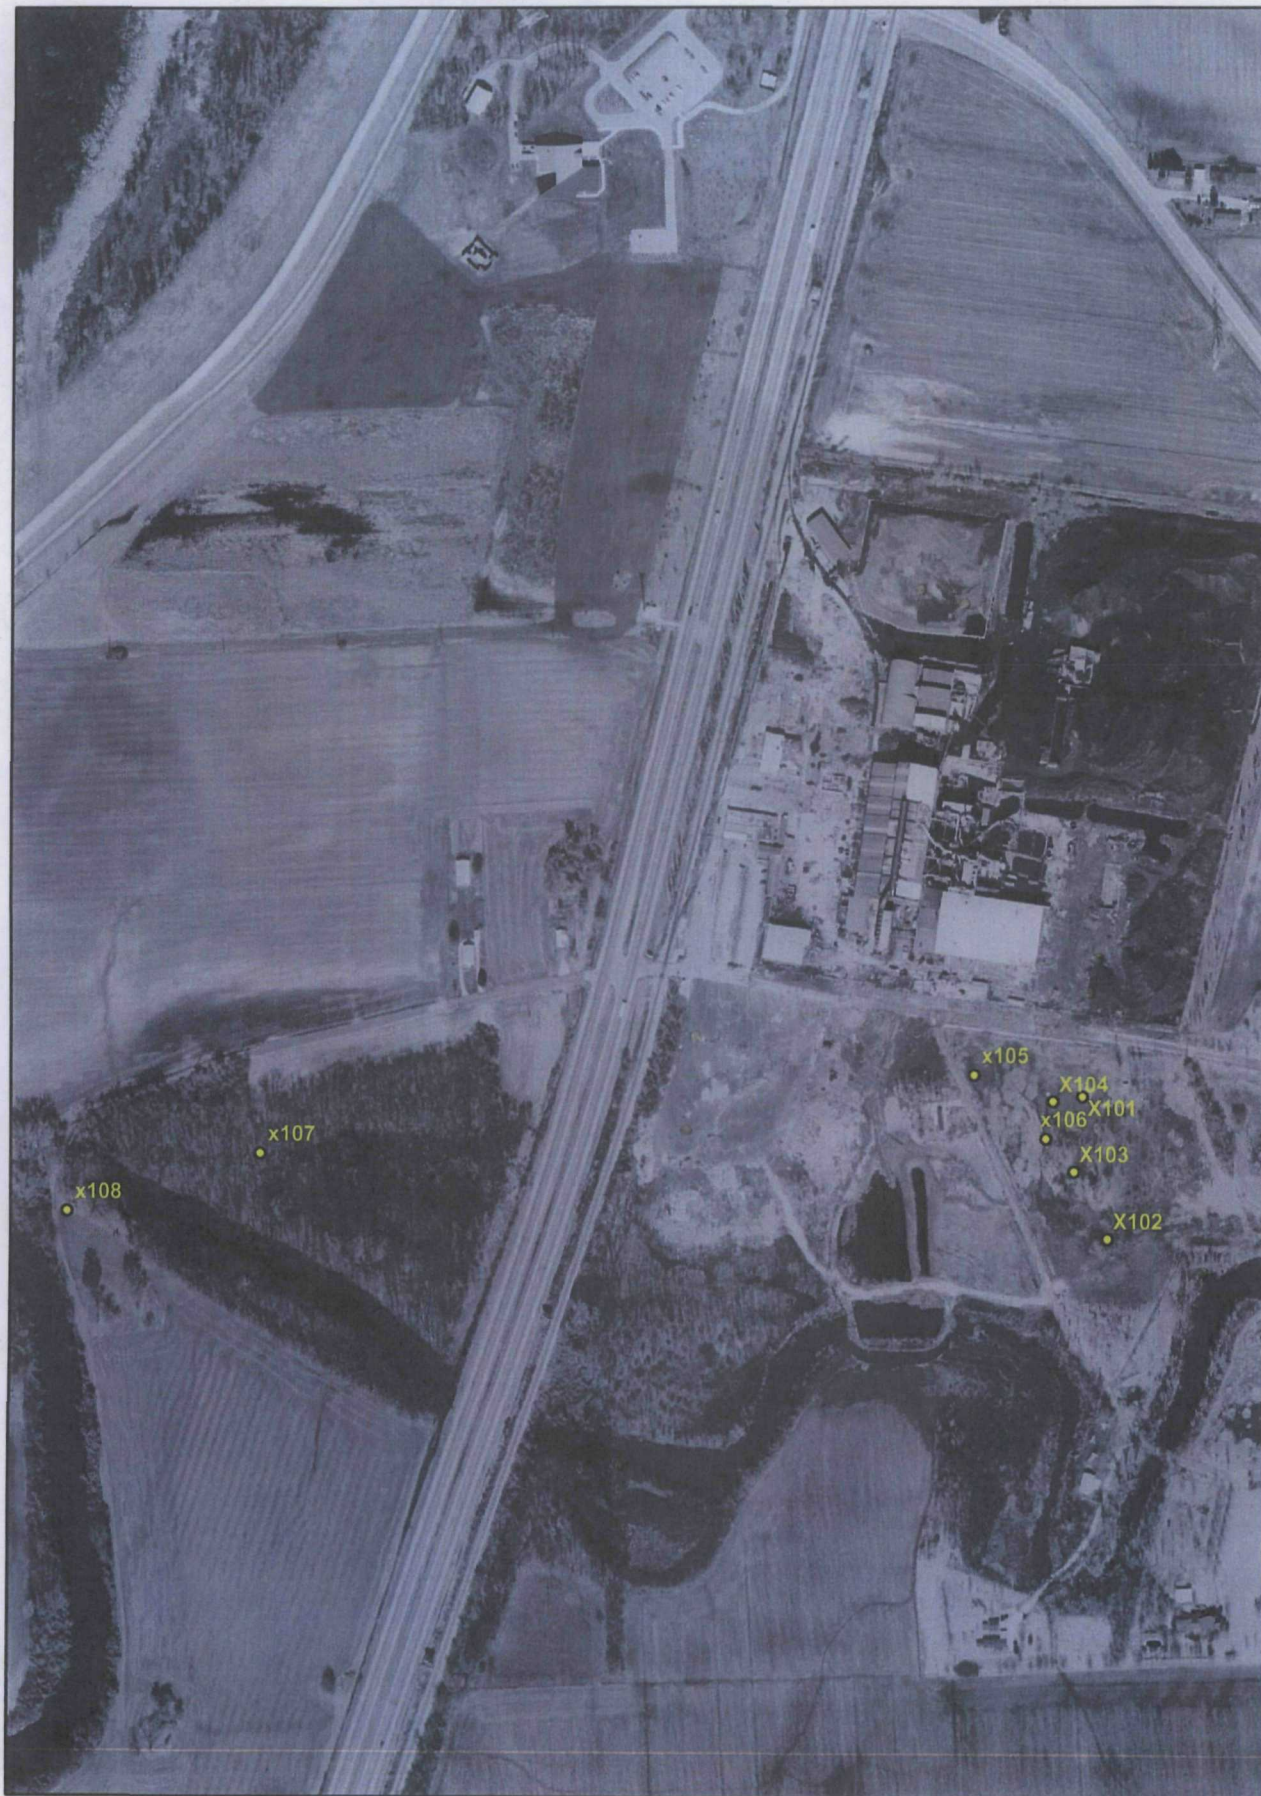
Figure 3  
Soil Sample Locations

Two samples were collected from the west of the site in an undisturbed area. Soil sample media was similar in nature being brown silt to brown silty clay. All samples were collected within the 0 – 6 inches from the surface of the soil. Sample descriptions are located in Table 1. Sample locations can be found in Figure 3.

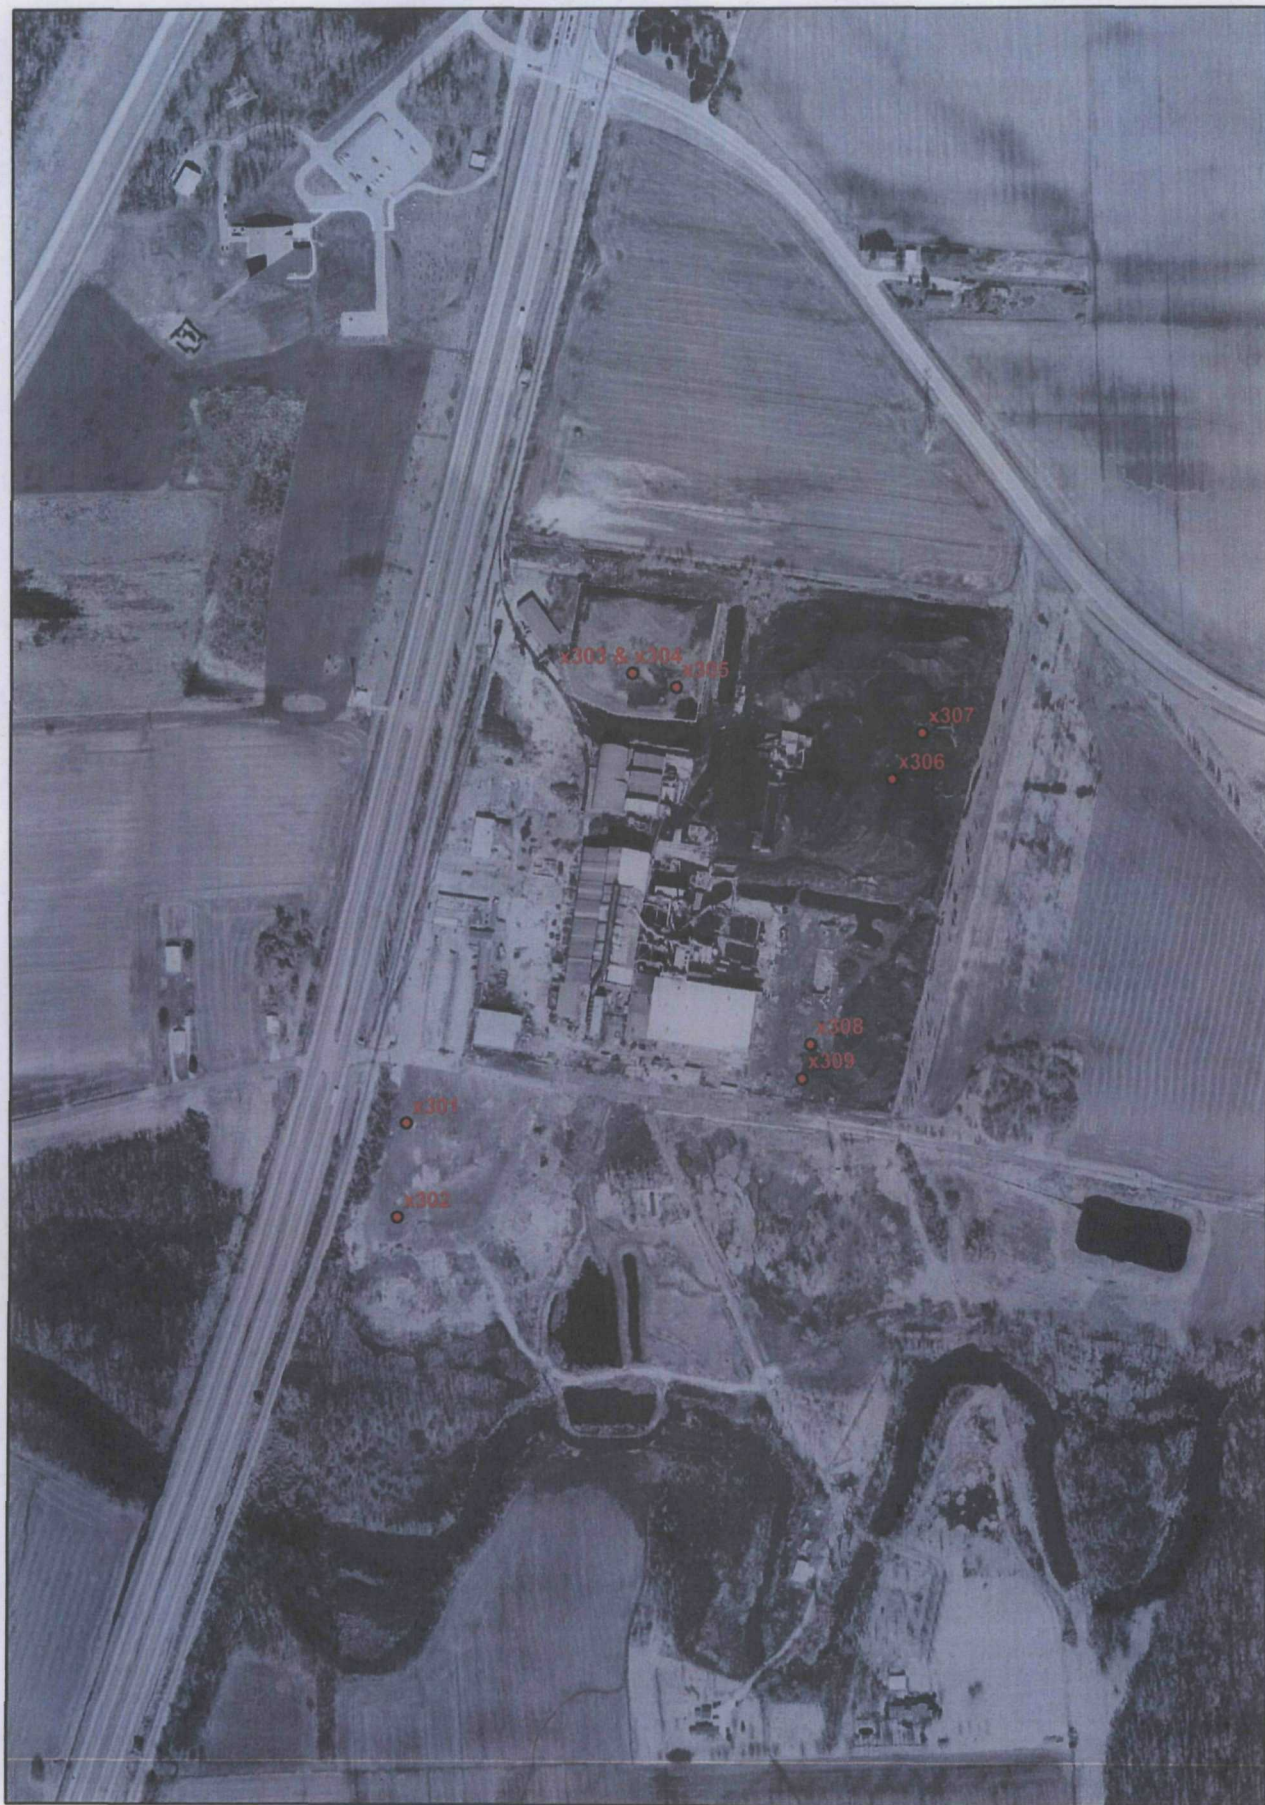
Figure 4  
Waste Sample Locations

Four samples were collected from these slag piles (X306-X309). These four samples were collected from the 0 – 4 inches from the surface of the slag piles. The analytical results from these samples were found to contain significantly elevated levels of beryllium, cadmium, chromium, copper, iron, lead manganese, mercury, nickel, silver, sodium and zinc. Table 3 shows the concentrations of these contaminants that were detected in the on-site slag and Figure 4 shows the locations of these samples.

Zinc oxide is a particulate material which was collected from the foundry furnaces exhaust gases. A bunker approximately 2.7 acres in size and storing approximately 35,000 tons of zinc oxide is located on the northern portion of the facility (see Figure 14). Three samples were collected from this area (X303 – X305) and were found to contain high levels of antimony, barium, beryllium, cadmium, calcium, cobalt, copper, lead, mercury, nickel, selenium, silver, sodium and zinc. There is no cap or liner to help prevent the contaminants from being spread off site via the air, groundwater or surface water pathways. Table 3 shows the concentrations of these contaminants that were detected in the zinc oxide on site and Figure 4 shows the locations of these samples.

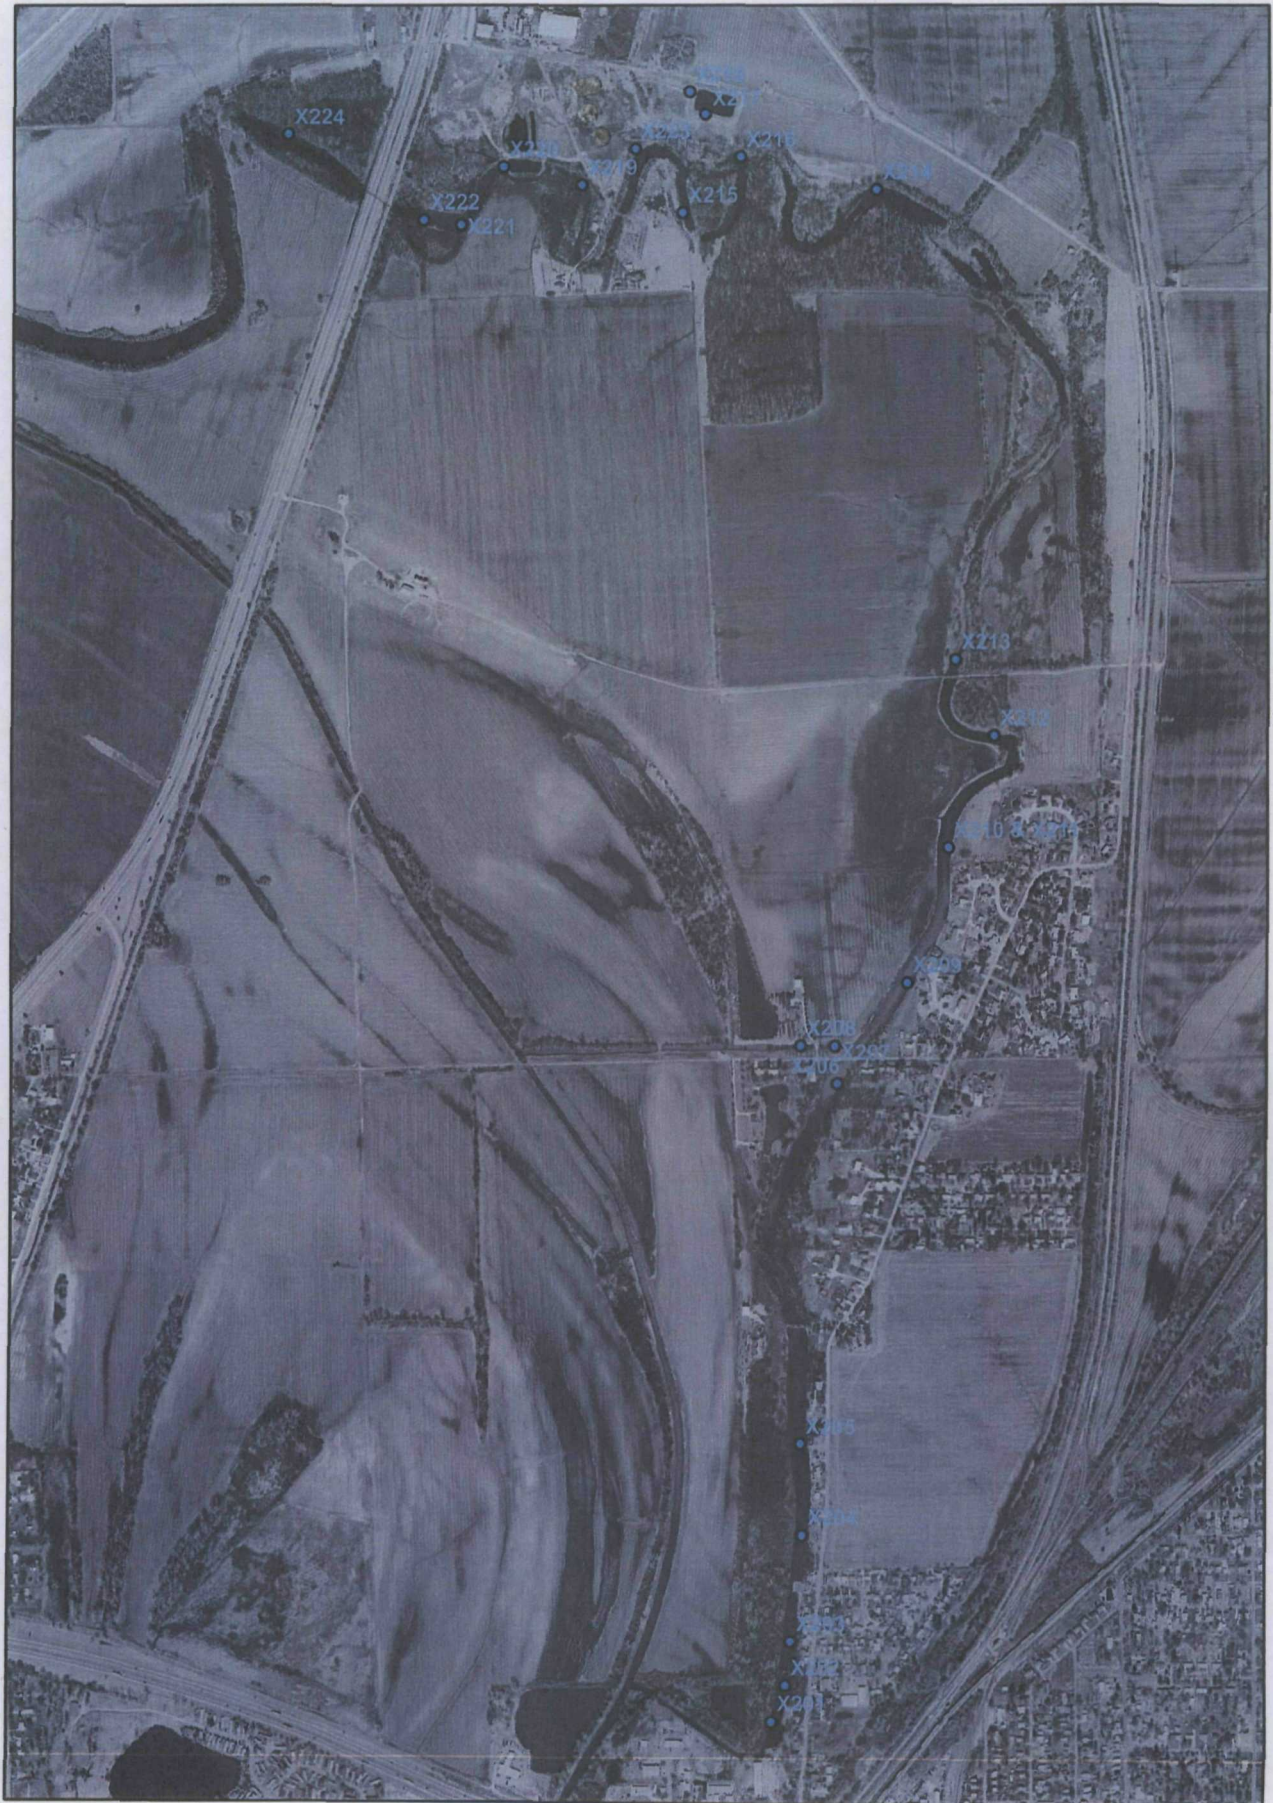
Figure 5  
Sediment Sample Locations

As can be seen on Table 4, the sediment samples collected from the tributary of Long Lake and Long Lake meet observed release criteria according to the Hazard Ranking System (HRS) for aluminum, arsenic, barium, beryllium, cadmium, calcium, chromium, copper, iron, lead, manganese, mercury, nickel, selenium, silver, sodium, thallium and zinc. These are all metals which were present at significantly elevated levels in the sources located onsite, the zinc oxide and slag piles. Thus, the elevated levels of these metals can be attributed to the Chemetco site. The documented portion of Long Lake that has been impacted extends to the furthest downstream sediment sample that was found to be contaminated which is sample X201 with sodium and mercury. X202 was the furthest sample which exceeded three times the background concentration for silver (see Table 4, Figure 5). X206 was the furthest sample from PPE1 (2.87 miles) which revealed elevated levels of cadmium (Table 4, Figure 5).

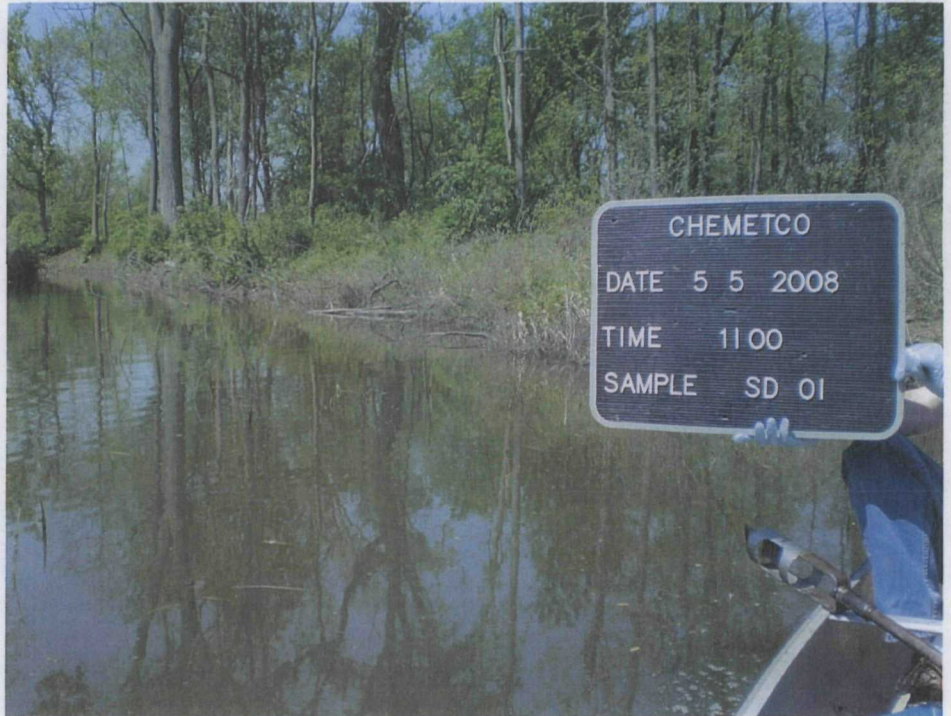
**COMMENTS:** SD01 correlates to X201. X201 was collected from 0-4 inches of sediment from a water depth of 2 ft. Sediment was a gray clay.

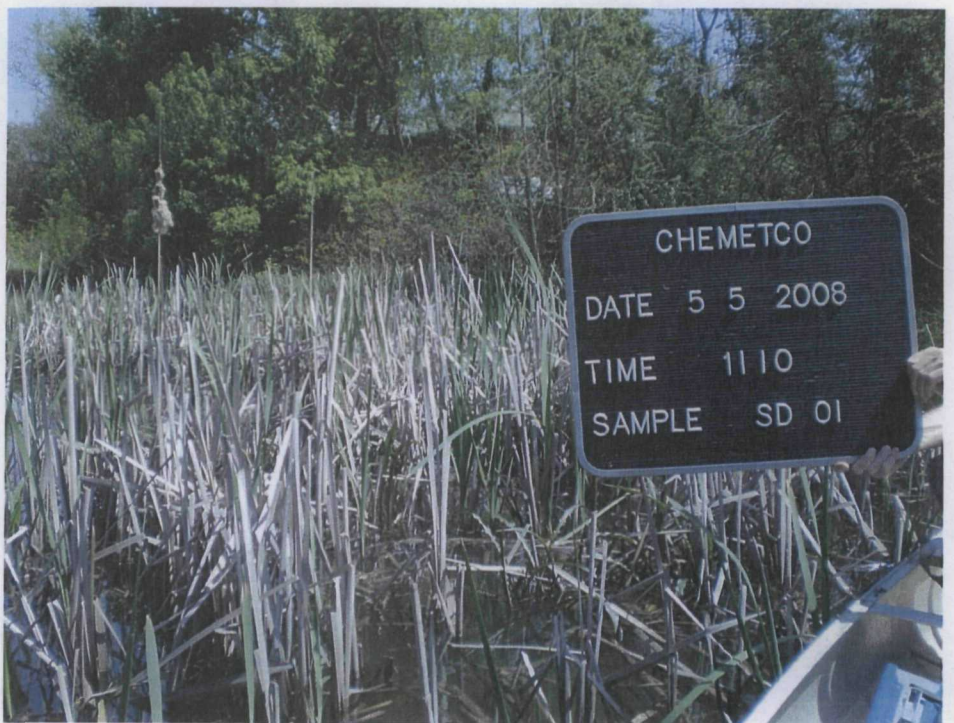
**COMMENTS:** Photo board is incorrect, should be sample SD02. SD02 correlates to X202 was collected from Long Lake near the township building. X202 was collected from a silty brown clay from a depth of 0-4 inches in 2 ft of water.

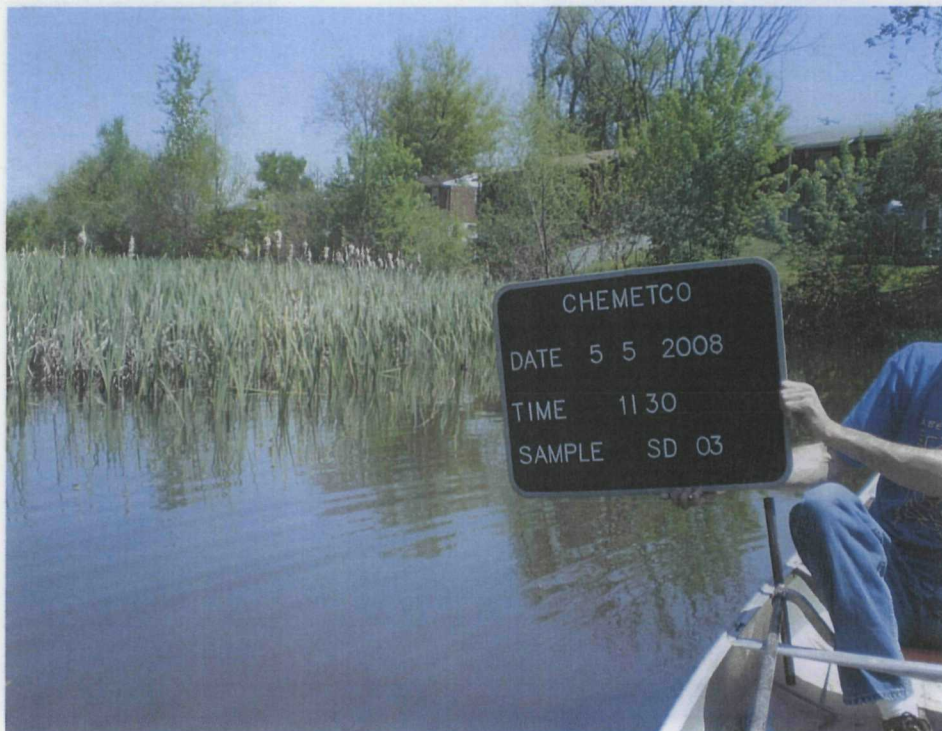
**COMMENTS:** SD03 correlates to X203. X203 was collected from a brown silt and clay mixture with little bits of gravel mixed in. X203 was collected from 0-4 inches from 2 ft of water.

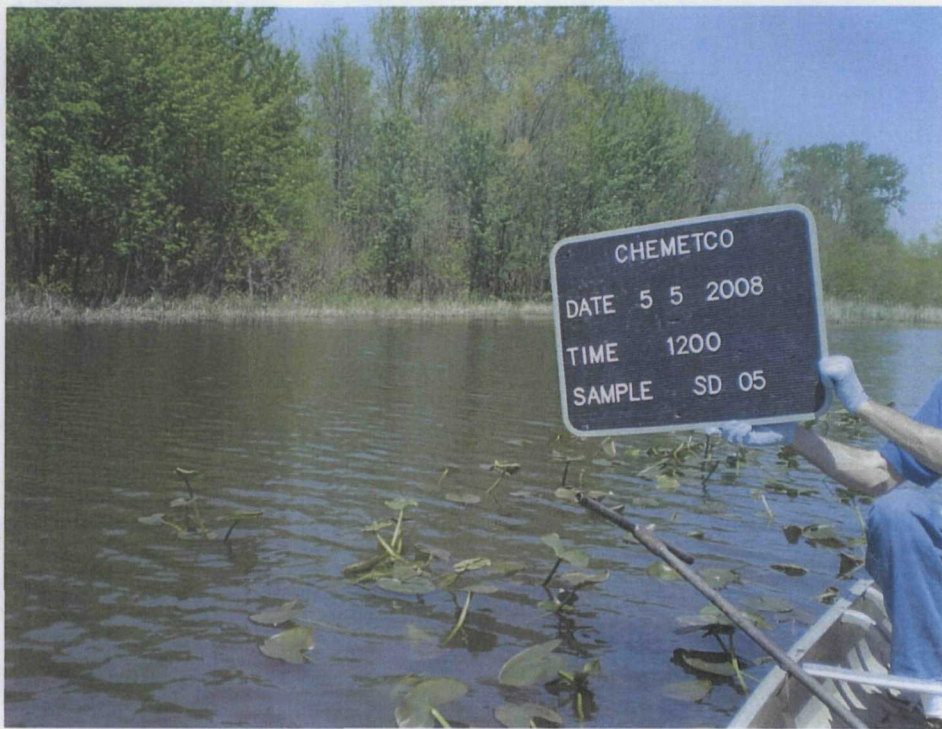
**COMMENTS:** SD05 correlates to X205. X205 was collected from a depth of 0-4 inches from a brown slightly stiff clay with some silt. Water depth was 3 ft.

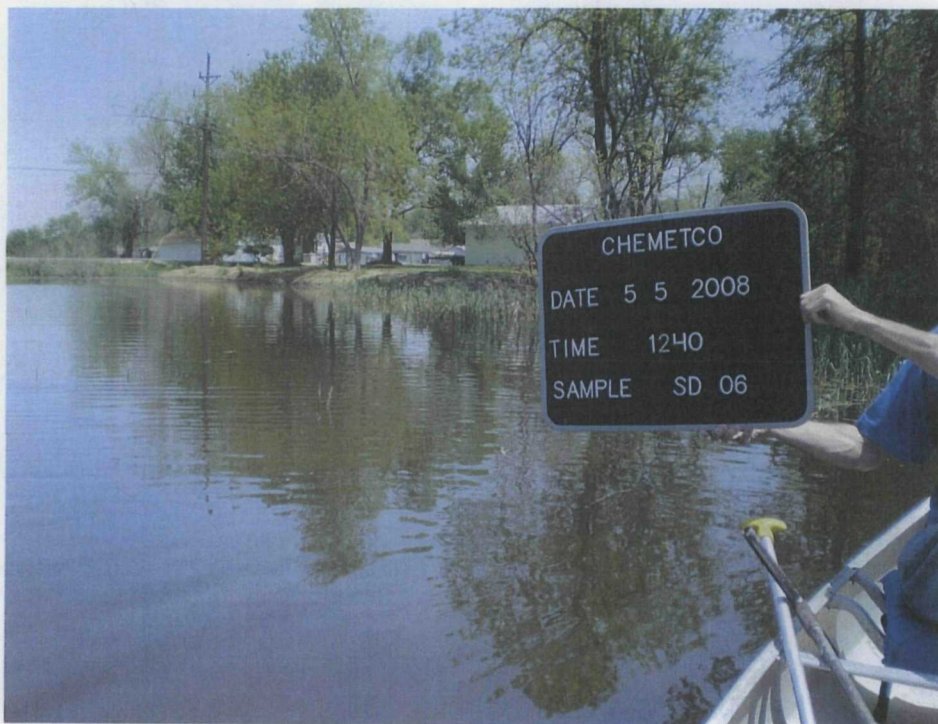
**COMMENTS:** SD06 correlates to X206. X206 was collected from a gray brown clay mixed with organic material from a depth of 0-4 inches. Water depth at this location was 3 ft.

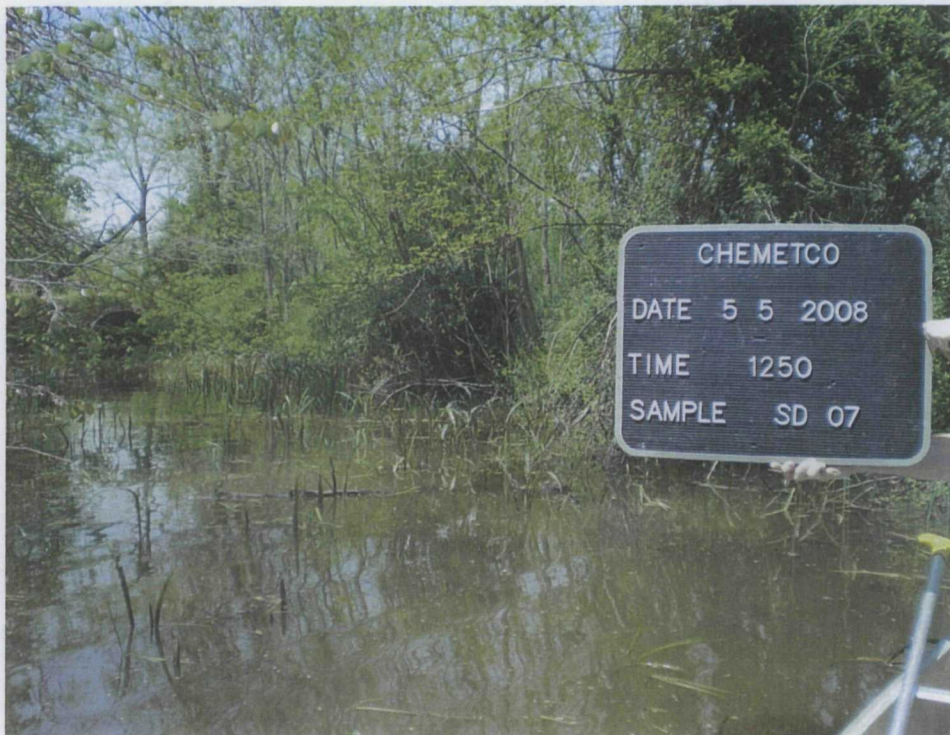
**COMMENTS:** SD07 correlates to X207. X207 was collected from a depth of 0-4 inches from a stiff mottled brown clay with a small amount of gravel with some silt. Water depth was 2.5 ft.

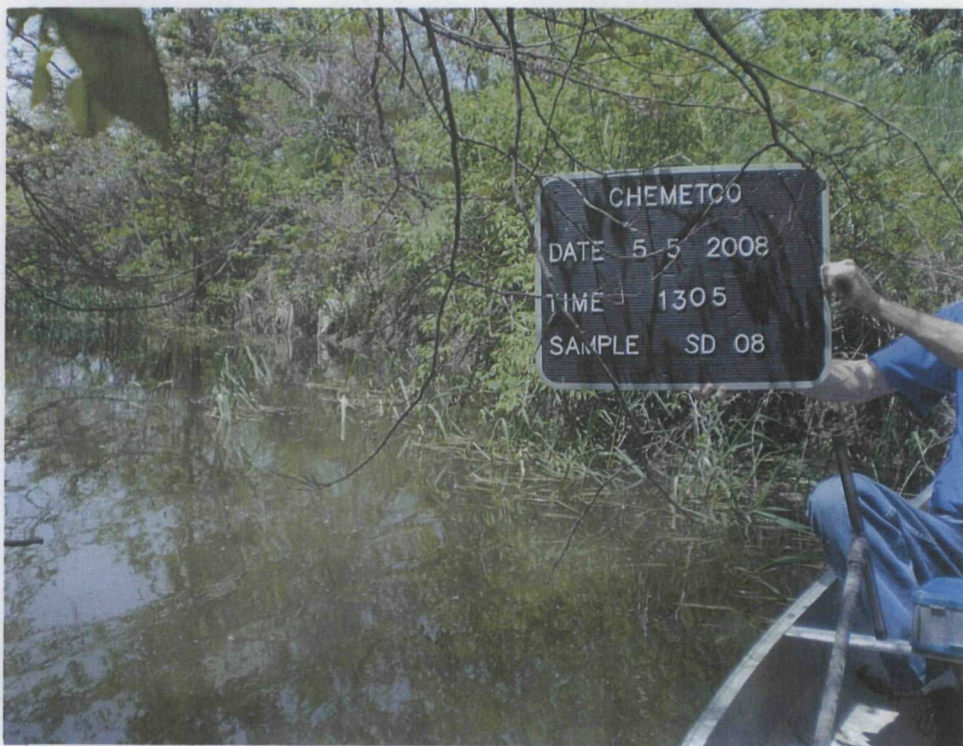
**COMMENTS:** SD08 correlates to X208. X208 was collected from a clayey silt which was gray brown in color. X208 was collected from a depth of 0-4 inches. Water depth at this location was 2 ft.

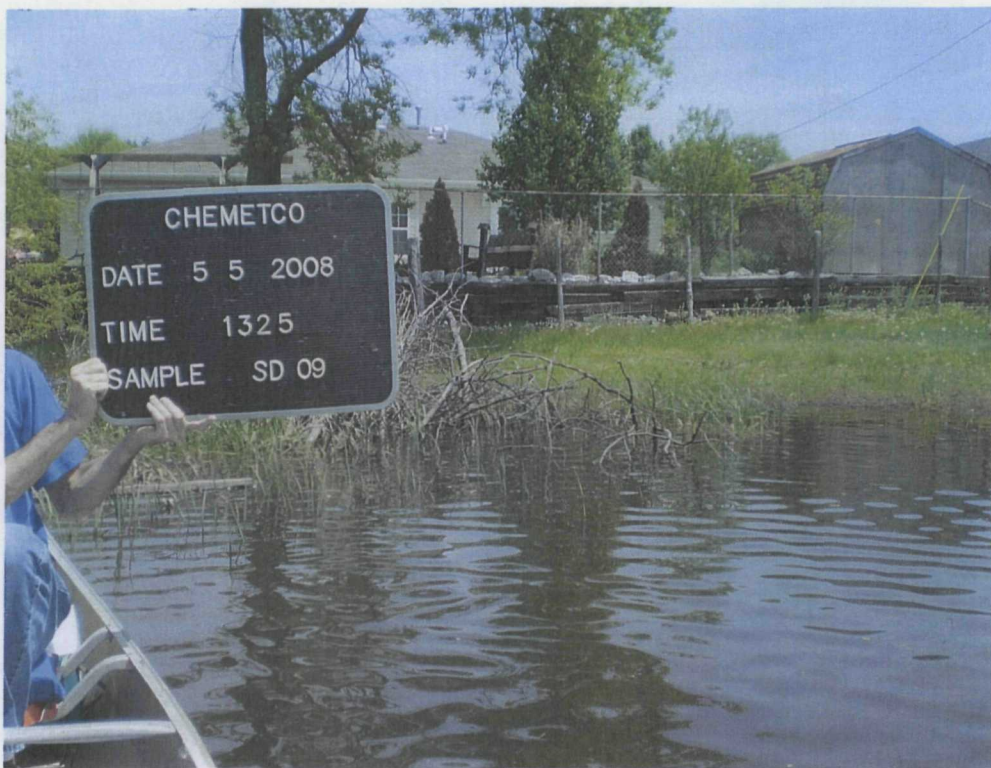
**COMMENTS:** SD09 correlates to X209. X209 was collected from 0-4 inches from a loose silty clay with organic matter. Water depth was 1.5 ft at this location.

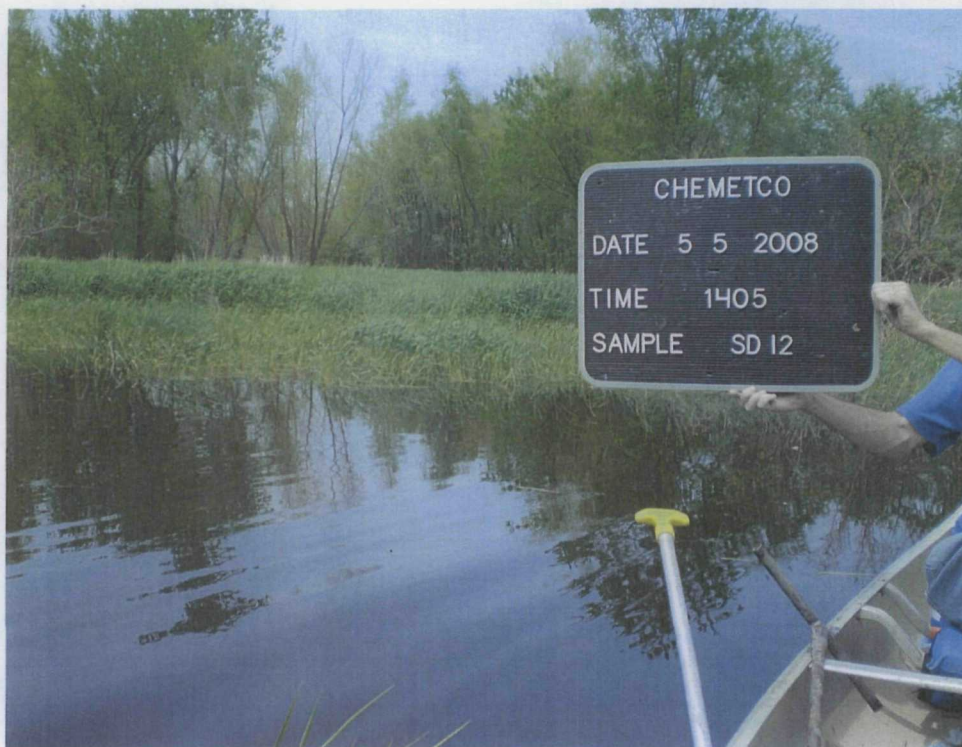
**COMMENTS:** SD12  
correlates to X212.  
X212 was collected  
from a depth of 0-4  
inches from a gray  
brown silty clay.  
Water depth from this  
location was 2 ft.

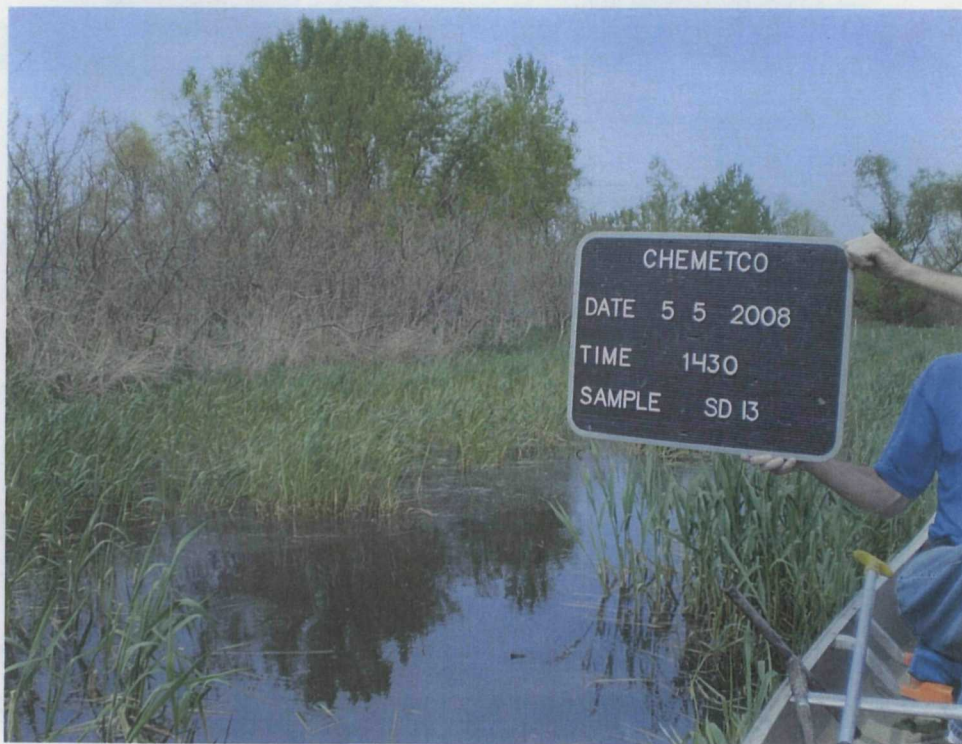
**COMMENTS:** SD13  
correlates to X213.  
X213 was collected  
from a depth of 0-4  
inches from a silty clay  
which was brownish  
gray in color. Water  
depth at this location  
was 1 ft.

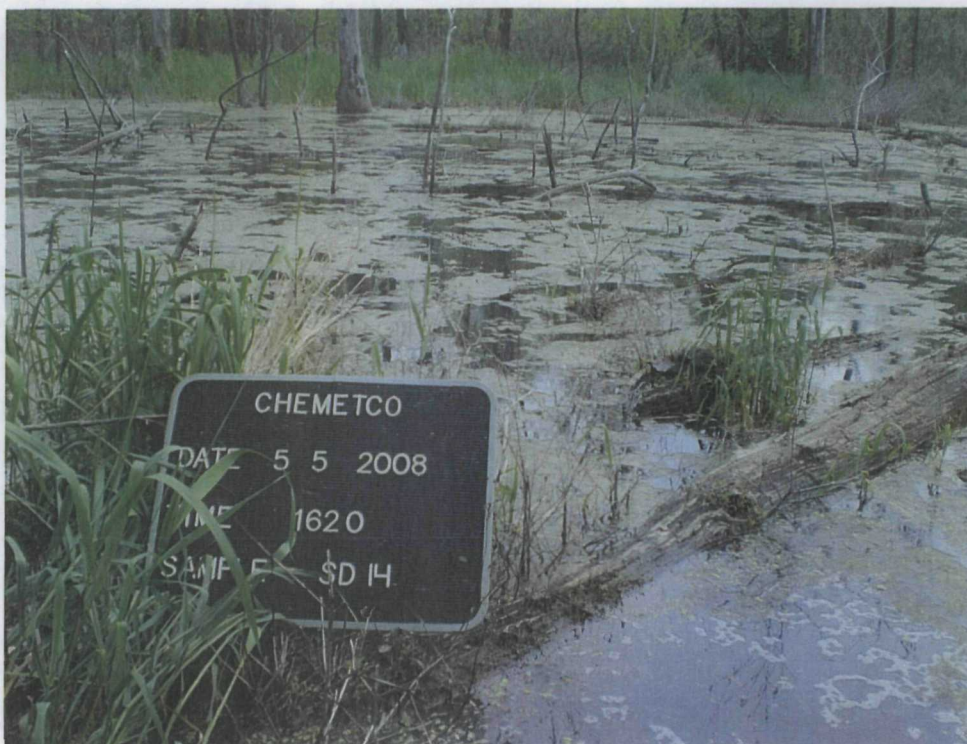
**COMMENTS:** SD14 correlates to X214. X214 was collected from a silt with organic matter. X214 was collected from 0-4 inches. Water depth was approximately 1.5 ft.

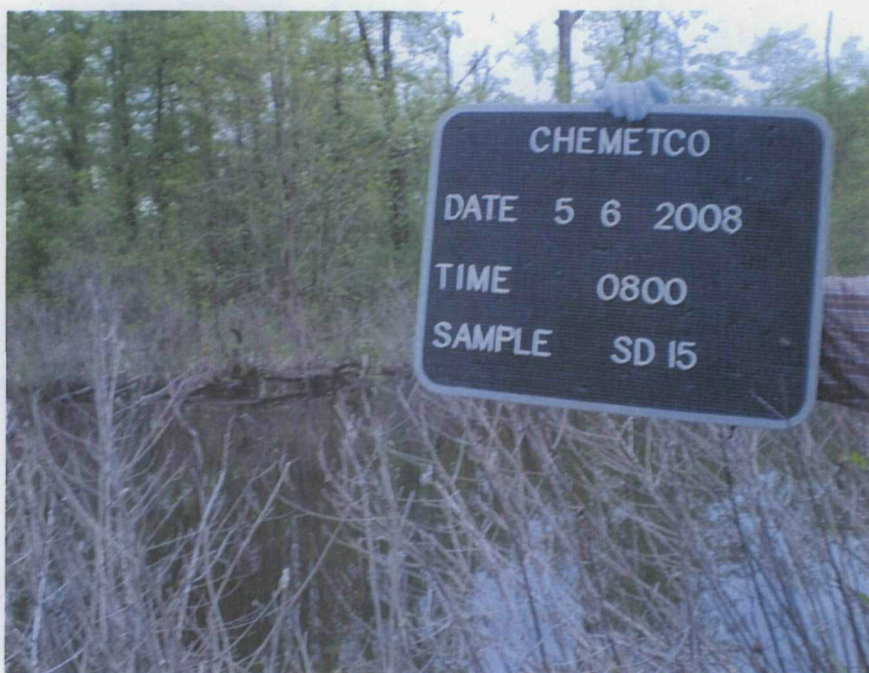
**COMMENTS:** SD15 correlates to X215. X215 was collected from sediments consisting of a gray brown silt. The water depth at this location was 1 ft. This sample was collected from the shore.

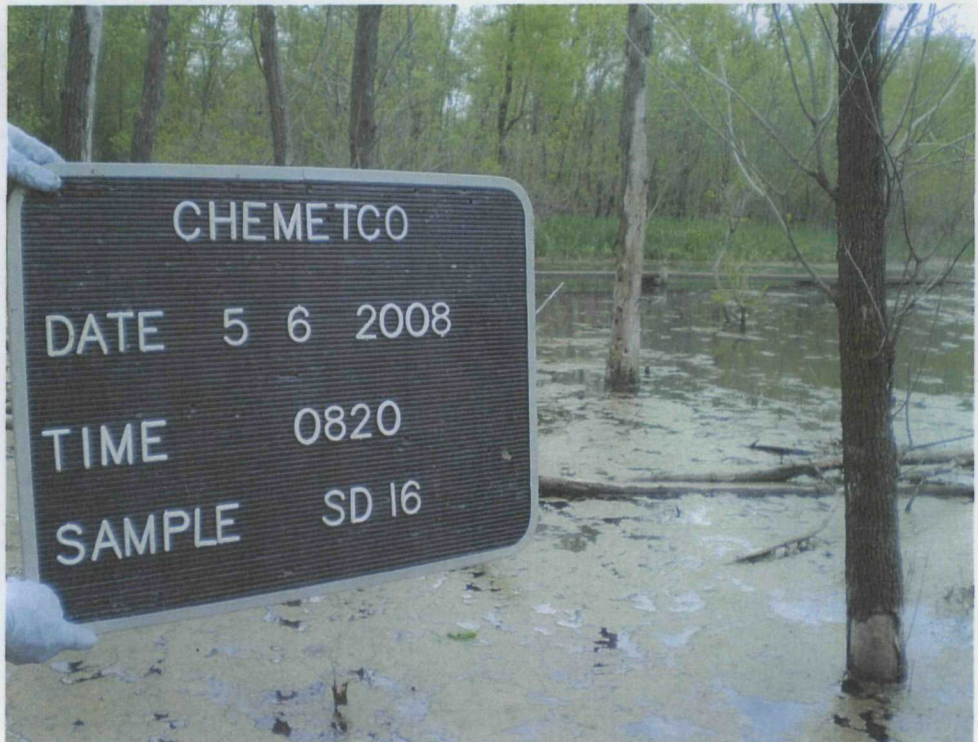
**COMMENTS:** SD16 correlates to X216. X216 was collected from 0-4 inches from gray silt from the shore. Water depth was approximately 1 ft.

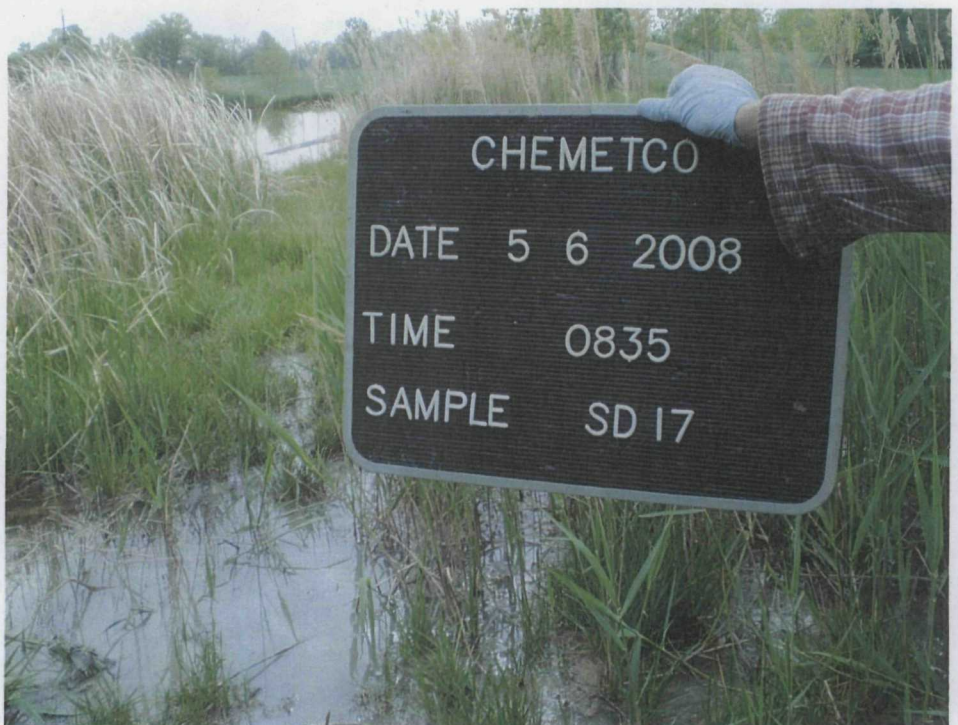
**COMMENTS:** SD17 correlates to X217. X217 was collected from the overflow from the retention pond to the east of the site. X217 was collected from the sediments on the dam where the water was overflowing. X217 consisted of light gray clay. Water depth was approximately 2 inches.

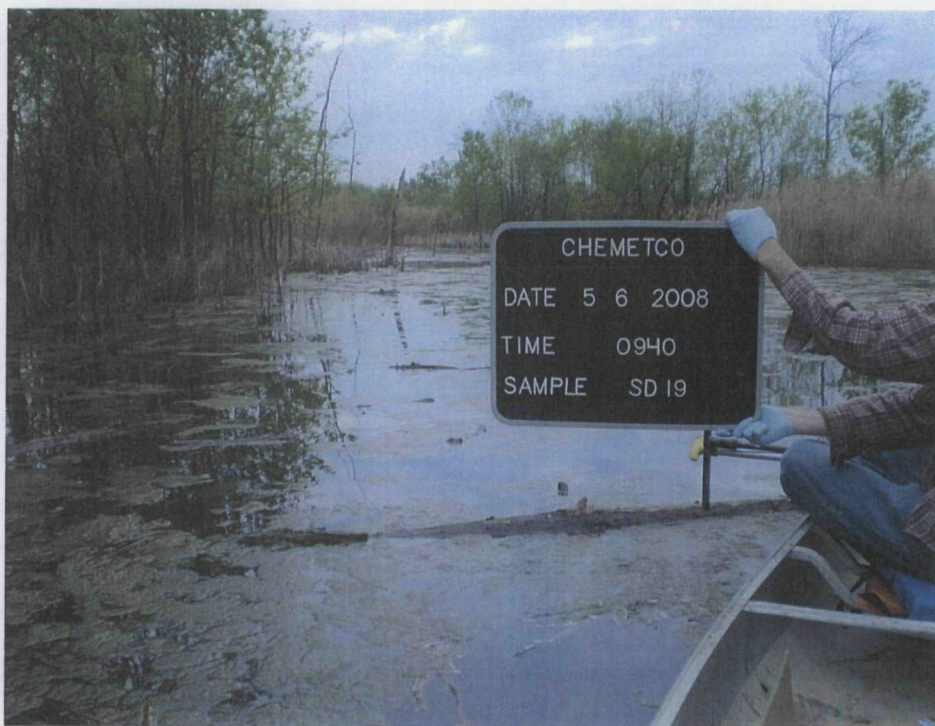
**COMMENTS:** SD 19 correlates to X219. X219 was collected from sediment from Long Lake near Chemetco. X219 consisted of black organic silty clay medium brown in color from a depth of 0-4 inches. Water depth was approximately 2 ft.

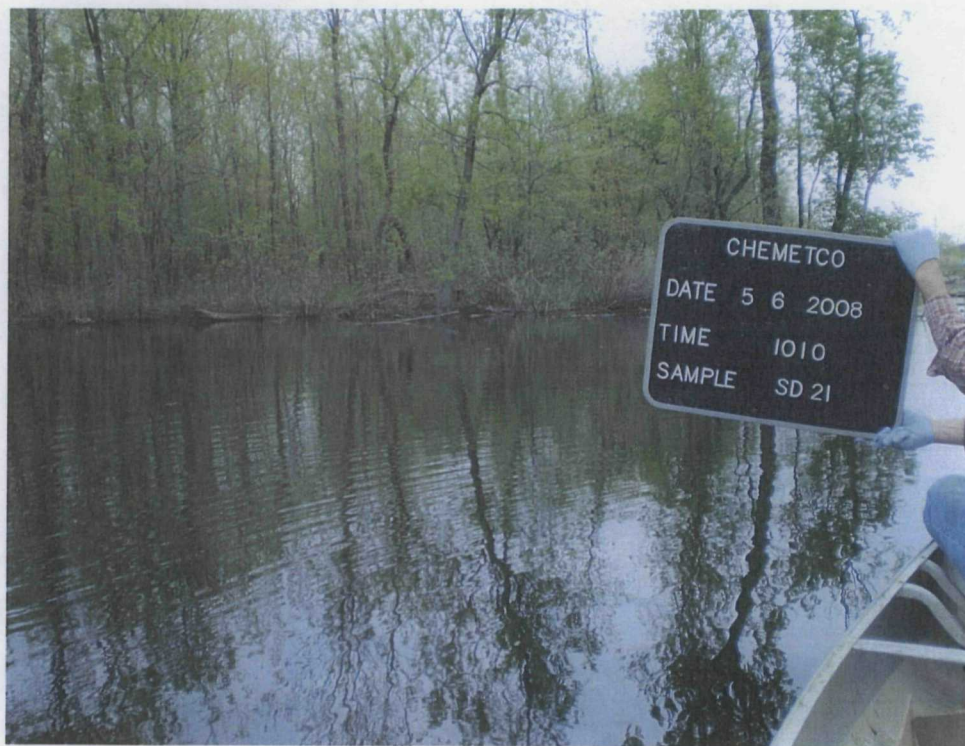
**COMMENTS:** SD21 correlates to X221. X221 was collected in the portion of Long Lake to the SE of Chemetco. X221 consisted of a black silt clay mix from 0-4 inches. Water depth was 5 ft.

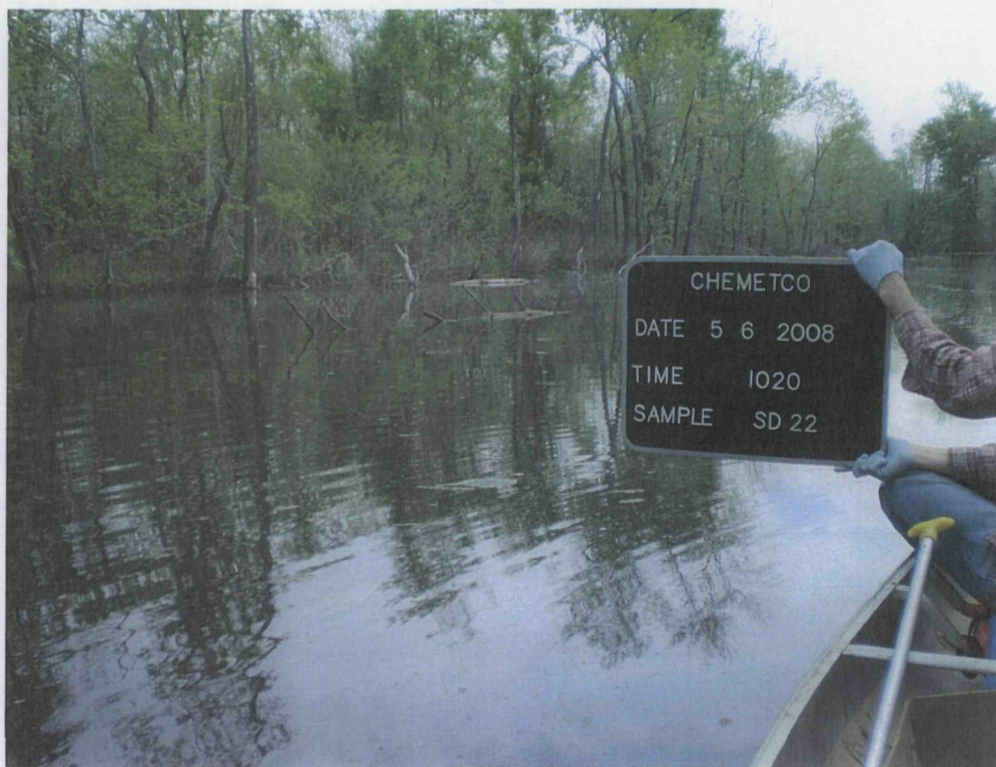
**COMMENTS:** SD22 correlates to X222. X222 was collected near the railroad tracks where Long Lake begins on the west. X222 consisted of a black silty orange material from 0-6 inches. Water depth was 4 ft.

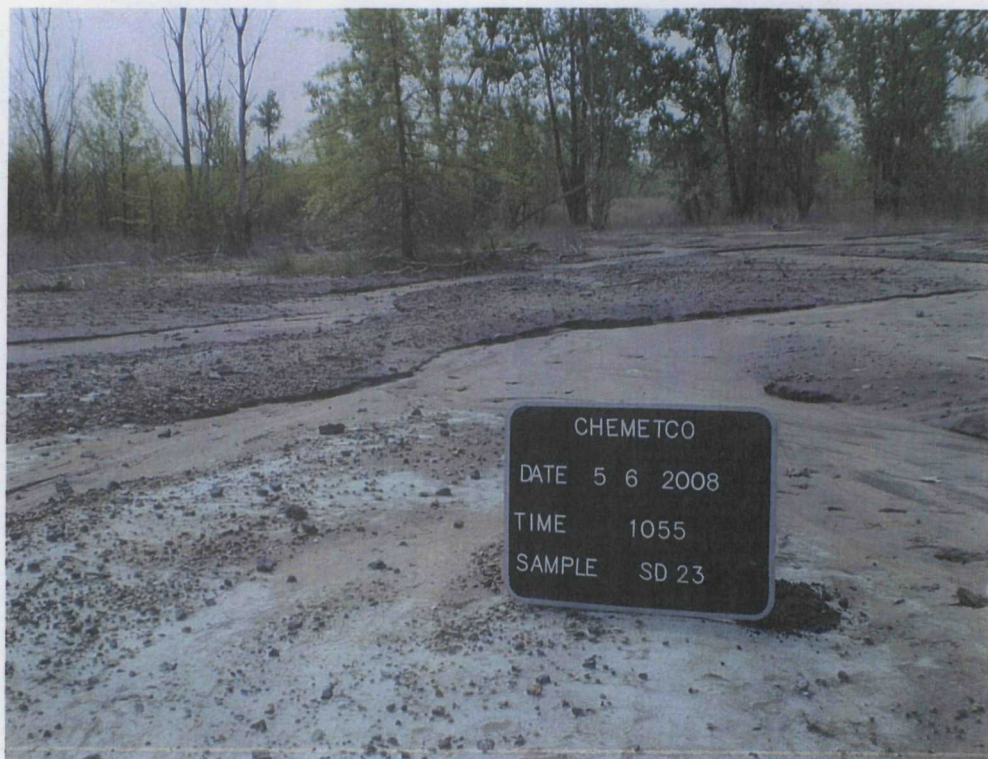
**COMMENTS:** SD23 correlates to X101. X101. X101 was collected from the zinc oxide spill area. X101 consisted of a light brown green material which was sandy silt. X101 was collected from 0-6 inches.

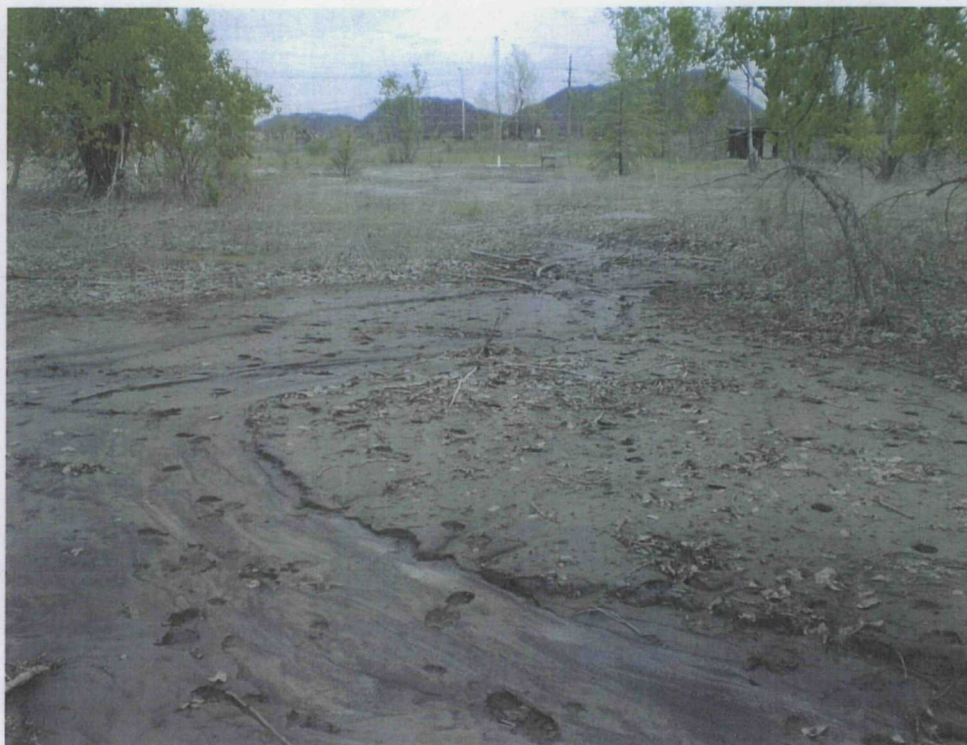
Picture taken of the drainage through the zinc oxide spill area. No vegetation was growing in this area.

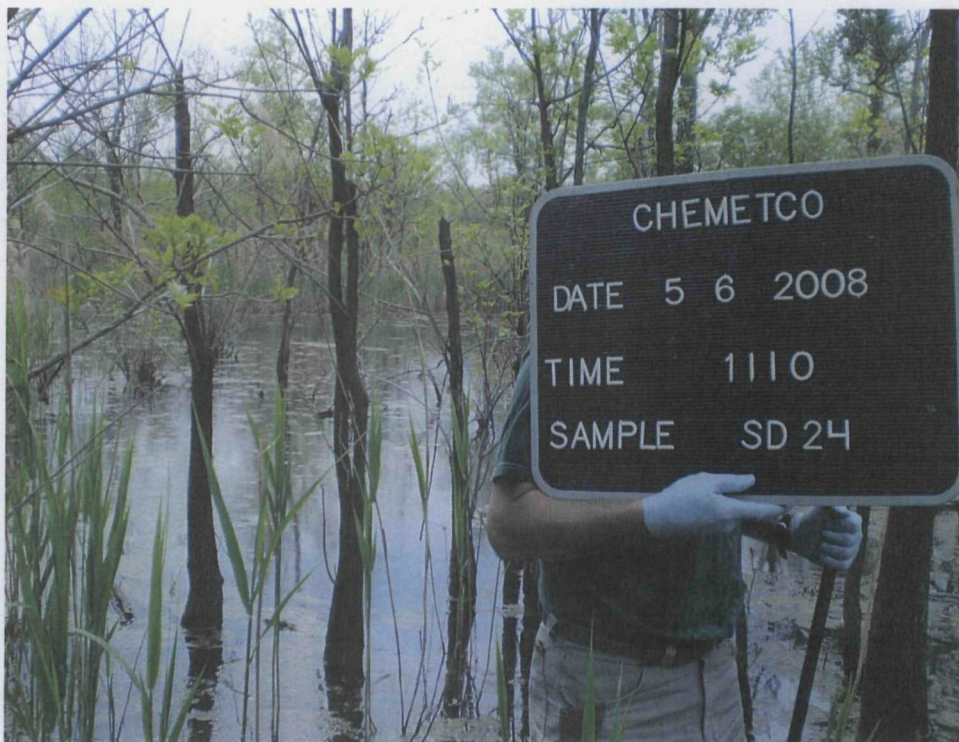
**COMMENTS:** SD24 correlates to X223. X223 was collected from the approximate confluence from the drainage from the zinc oxide spill area to Long Lake. X223 was collected from 0-6 inches from a silty clay. Water depth was 1 ft.
